ALTERNATIVE TREATMENTS OF OVER AND UNDERCROSSINGS FOR USE BY BICYCLISTS, PEDESTRIANS AND THE HANDICAPPED

January 1981
Final Report

1. Report No. FHWA-RD-79-70		2. Government Accession No.		3. Recipient's Catalog No.	
4. Title and Subtitle EFFECTIVE TREATMENTS OF OVER AND UNDERCROSSINGS FOR USE BY BICYCLISTS, PEDESTRIANS AND THE HANDICAPPED,				5. Report Date January 1981

6. Performing Organization Code	
7. Author(s) C. De Leuw, Jr., F. Danielson, W. Kudlick, S. Swan				8. Performing Organization Report No.	
9. Performing Organization Name and Address De Leuw, Cather & Company 120 Howard Street San Francisco, CA. 94105				10. Work Unit No. (TRAIS) FCP 31E3032

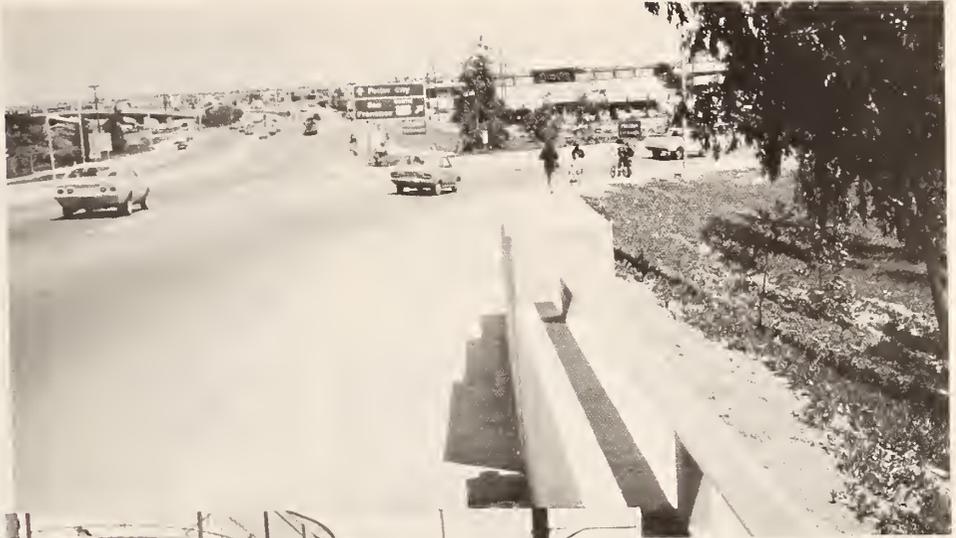
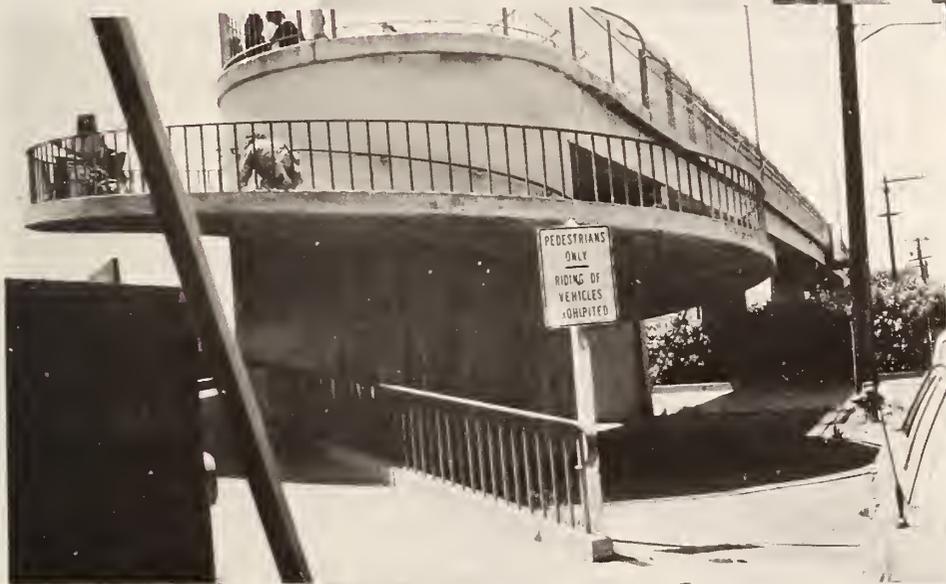
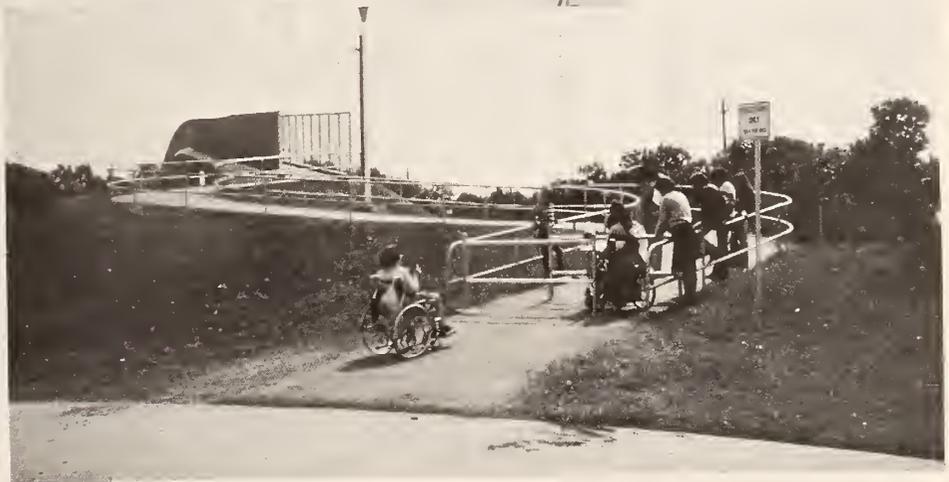
Figure 9. HANDICAPPED USER PANEL EVALUATION SITES
California

Pedestrian crossing
of Greeway on-ramp
Millbrae Avenue

Spiral approach
ramp to Mt. Diablo
Avenue overcrossing

Approach to
Ahwanee
pedestrian
overcrossing.
Note Z gate
on slope

The three sites selected in the Bay Area included two exclusive pedestrian overpasses and one overpass shared with motor vehicles. All three structures provide access across a freeway. Various site details are listed in Table 6. Also see photographs, Figure 9.

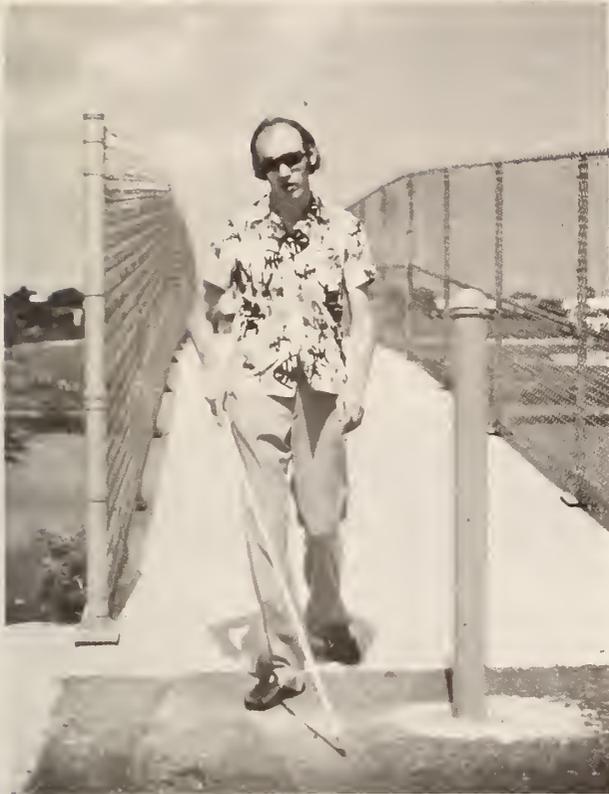
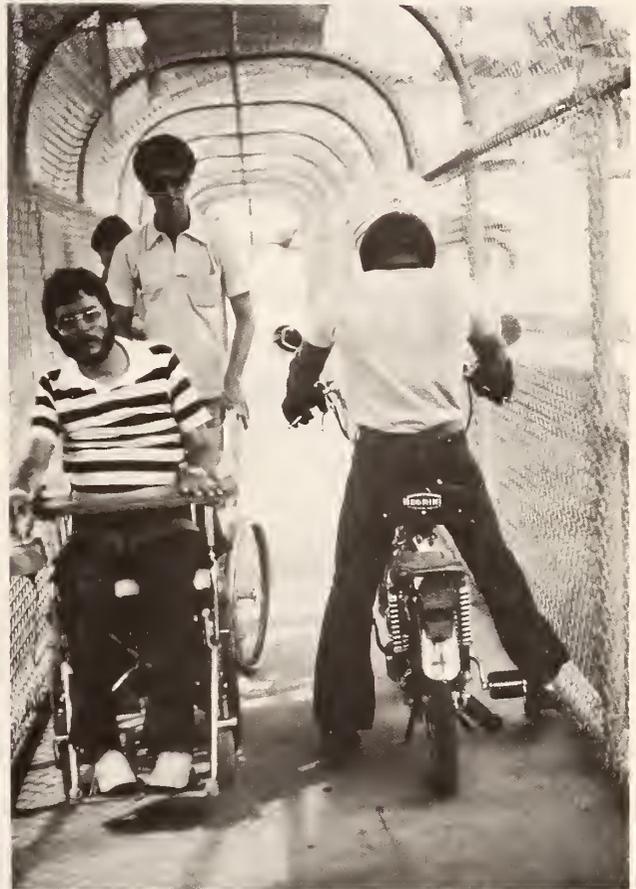
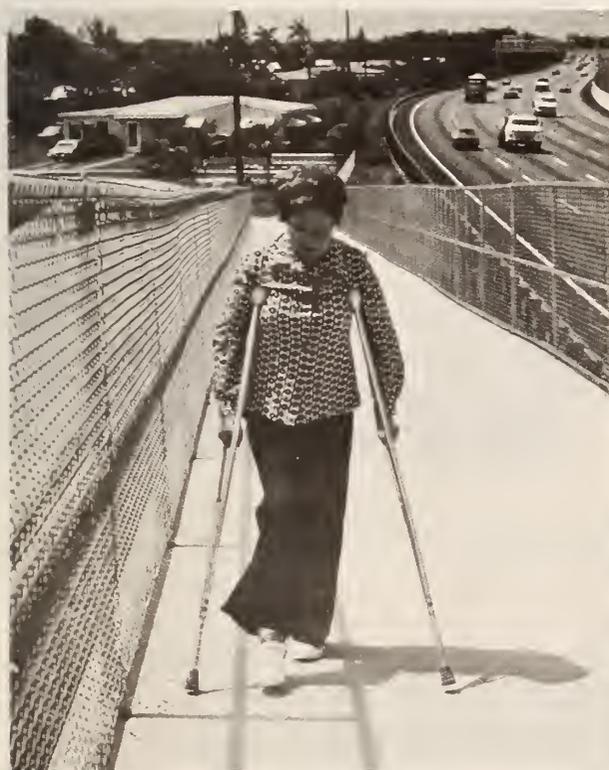
Figure 10. HANDICAPPED USER PANEL EVALUATION SITES
Florida

Blind pedestrian crossing
bridge over canal
Plantation, Florida

Passing on narrow bridge
over Route 27
Hialeah, Florida

Long ramp serving pedestrian
overcrossing of Palmento Exprway.
Miami, Florida

The four sites selected in the Miami, Florida area were all exclusive pedestrian/bicycle facilities. Two of the structures spanned a freeway; one bridge crossed a major arterial and canal and the fourth bridge simply provided access across a canal. The site characteristics are summarized in Table 7 and photographs can be seen in Figures 10 and 11.

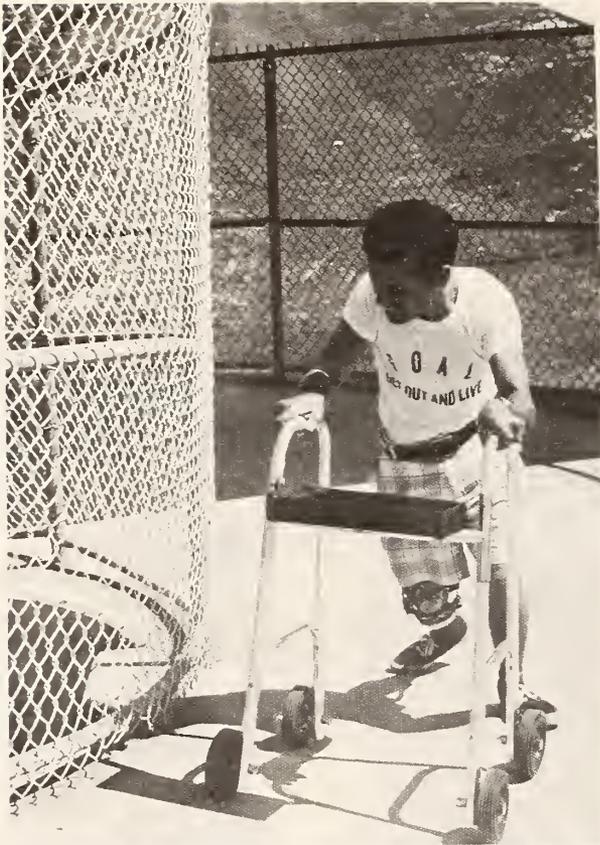
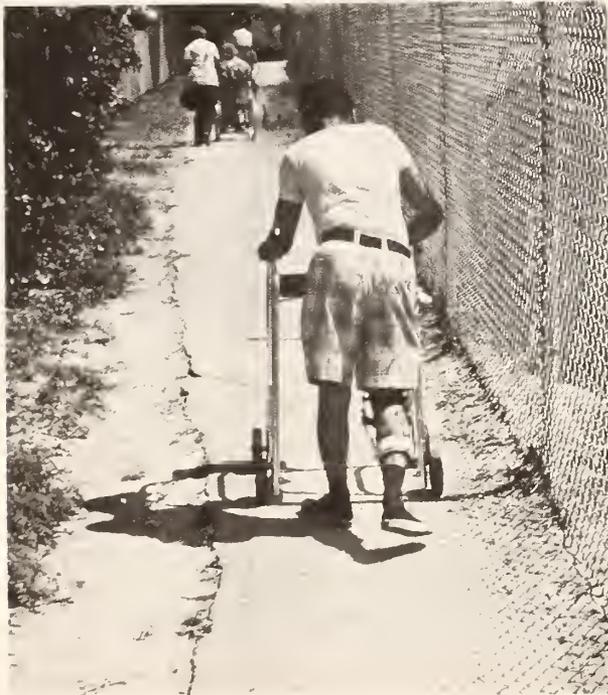
Figure 11. HANDICAPPED USER PANEL EVALUATION SITES
Florida

Ascending steep inside edge of spiral ramp
Pompano Beach, Florida

Narrow variable width path leading to overcrossing
Pompano Beach, Florida

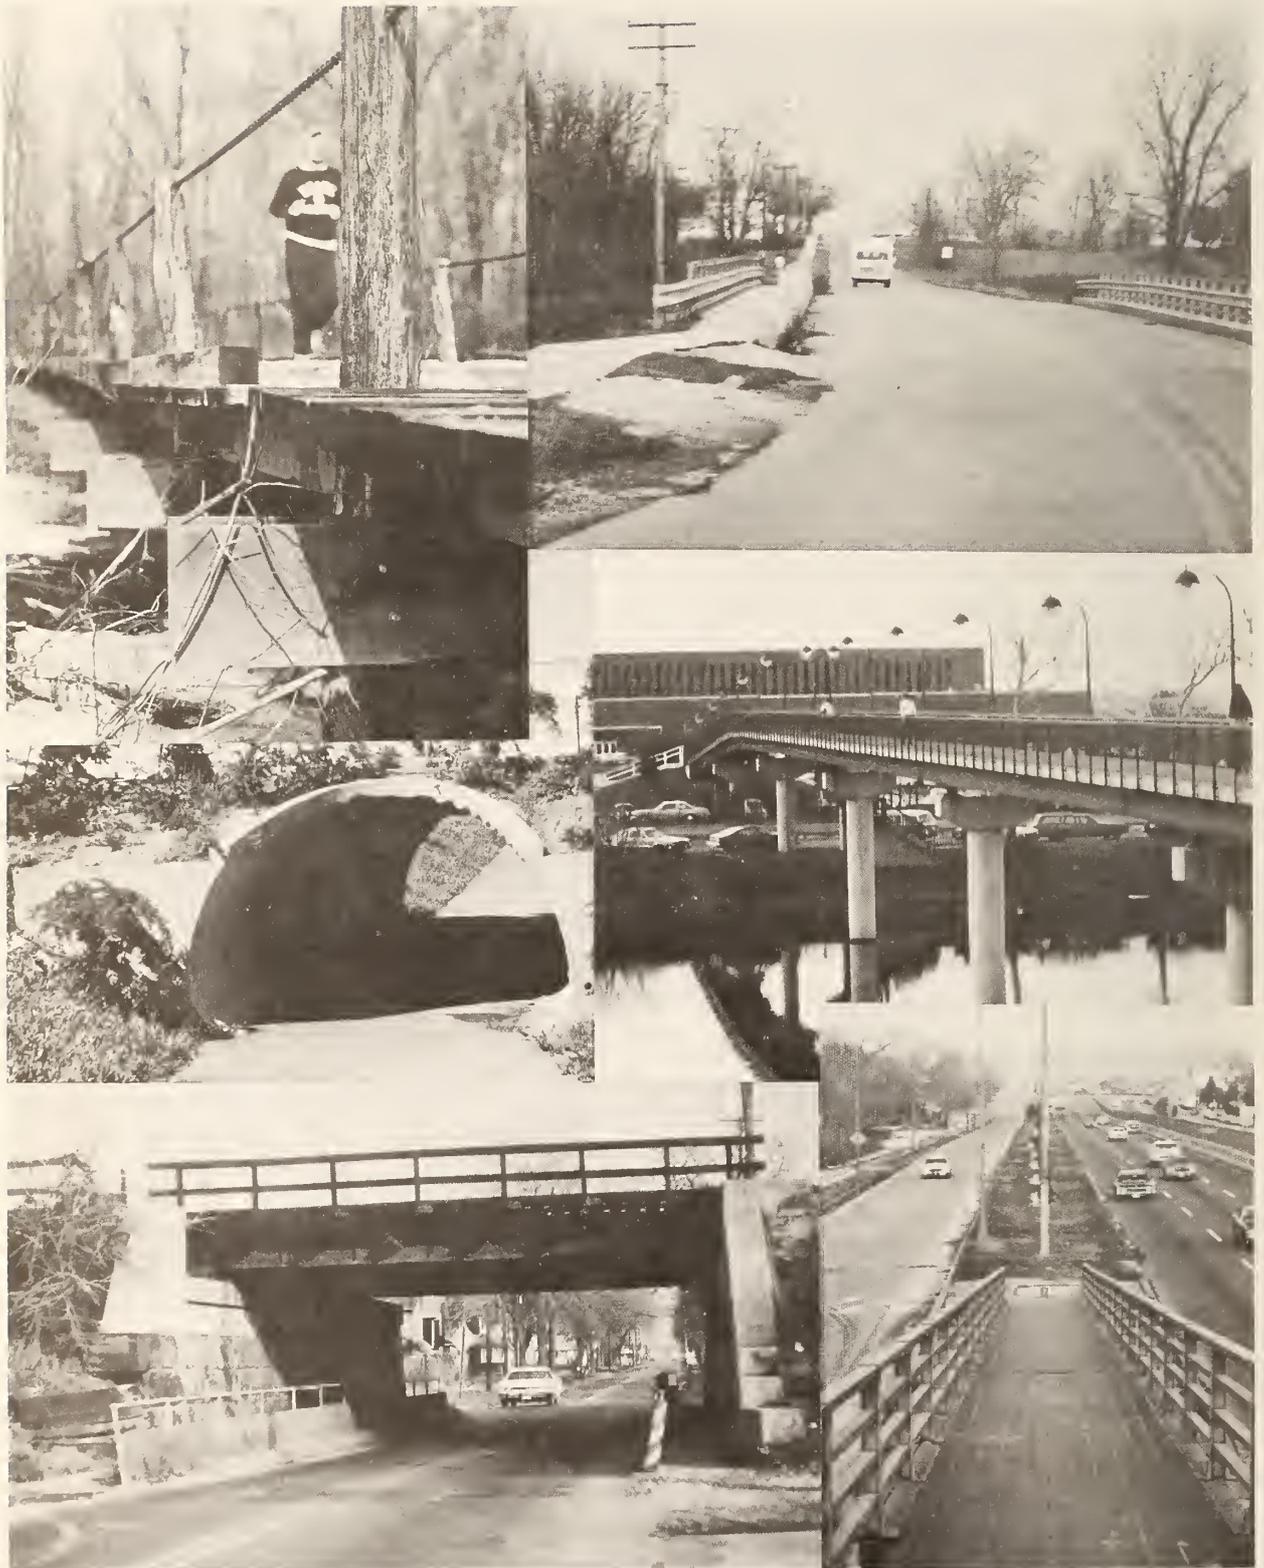
Figure 12. SELECTED SITE VIEWS

Photographic views presented in Figure 12 show a variety of different structural treatments. The exclusive bicycle and pedestrian undercrossing of a local roadway is in a planned unit development. An older railroad underpass shows where metal railing and splash boards protect pedestrians using narrow sidewalks. The bicycle and pedestrian overcrossing with lighting connects to a parking lot on a university campus. The overcrossing ramp gains access from a median between a freeway and a frontage road. A sidewalk on one side of the roadway crosses a small bridge on the outskirts of a small town. Finally, a wooden bridge with wooden piling built through a marsh is designed so the deck can be jacked up to compensate for differential settlement.

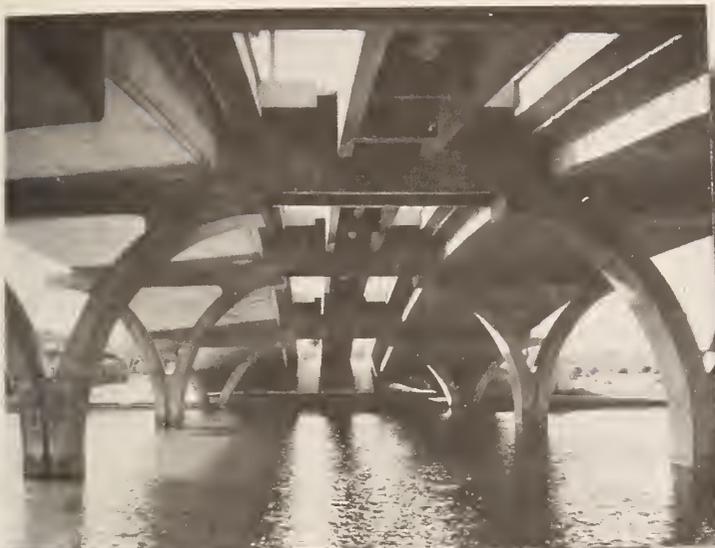
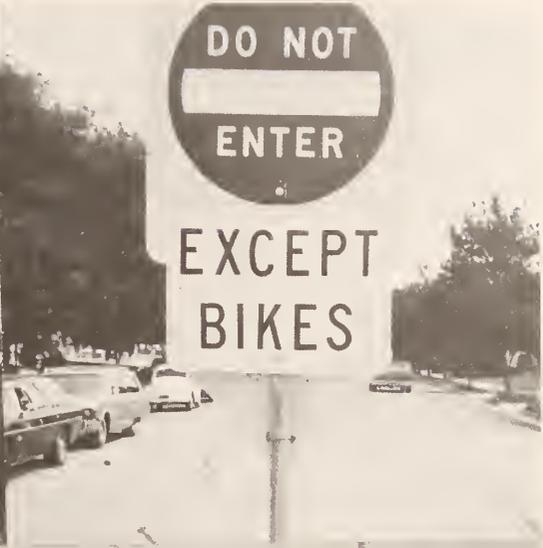
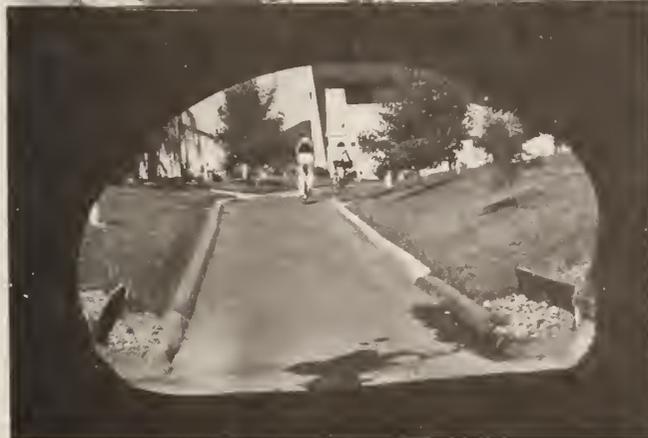
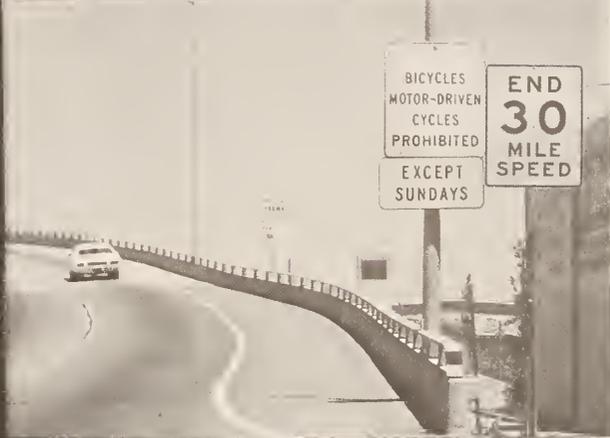
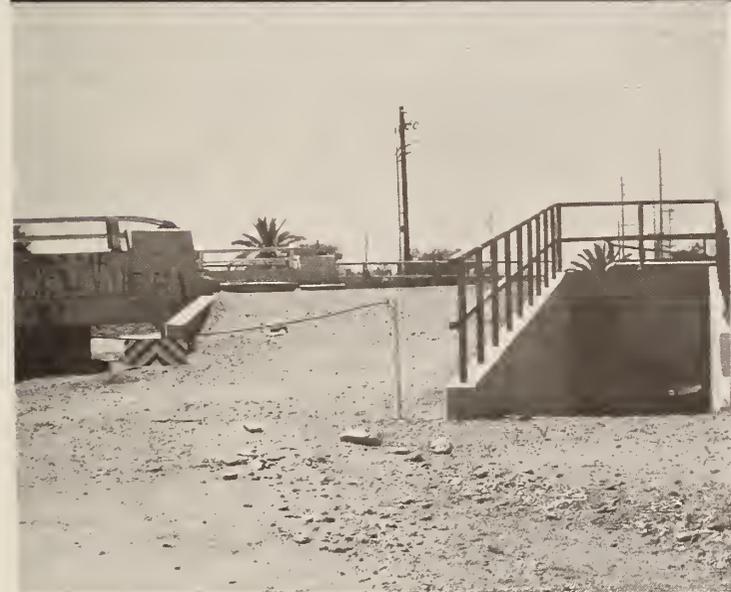
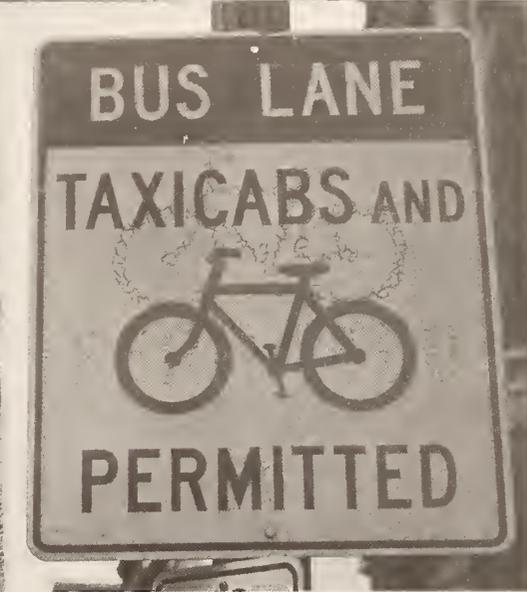
Figure 13. SELECTED SITE VIEWS

Several signs indicating various unique traffic control strategies are shown on Figure 13. Additional photos illustrate an underpass from a canal levee underneath the approach to a highway bridge. This provides levee protection from high water. The other undercrossing is constructed of corrugated metal pipe and connects a residential area to a major street on the other side of an elevated railroad

track. The final photo displays the underside of a dual highway bridge where a centrally located pedestrian and bikeway is incorporated in the structure. Access returns to each side of the roadway from a pathway under the bridge abutments.

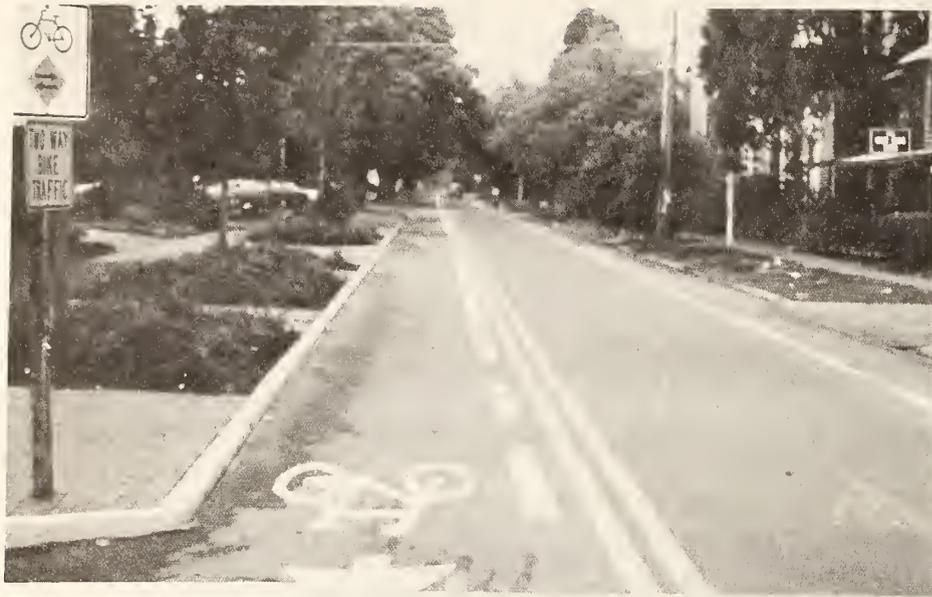
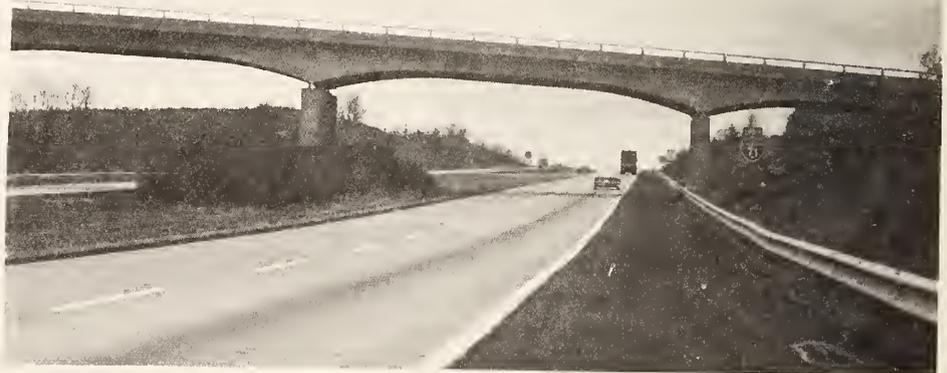
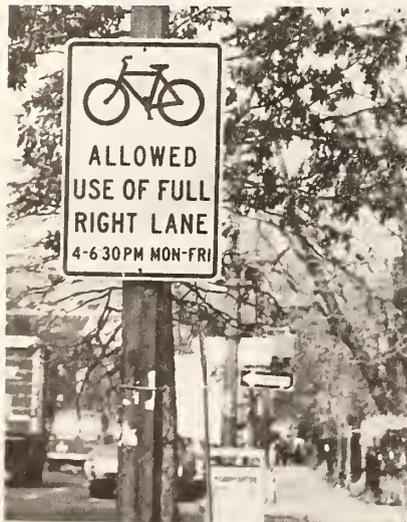
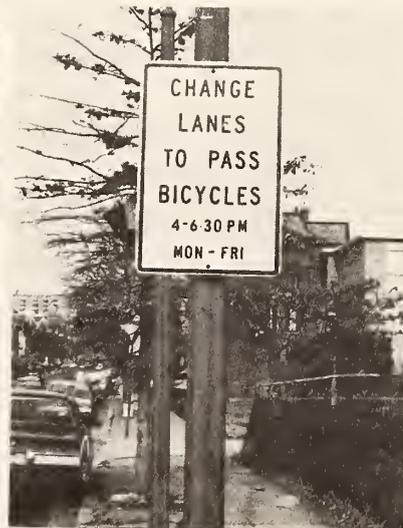
Figure 23. SIGNING AND STRIPING

Lane reduction from narrow two-way street to one-way with two-way bike traffic

Shoulder a potential for use on limited access roadway

Primary right-of-way assigned to bikes

may also allow lane reduction without adversely impacting auto travel characteristics. Under special circumstances a one way street striped for two way bicycle travel as exists in Eugene, Oregon may be applicable. (See Figure 23.)

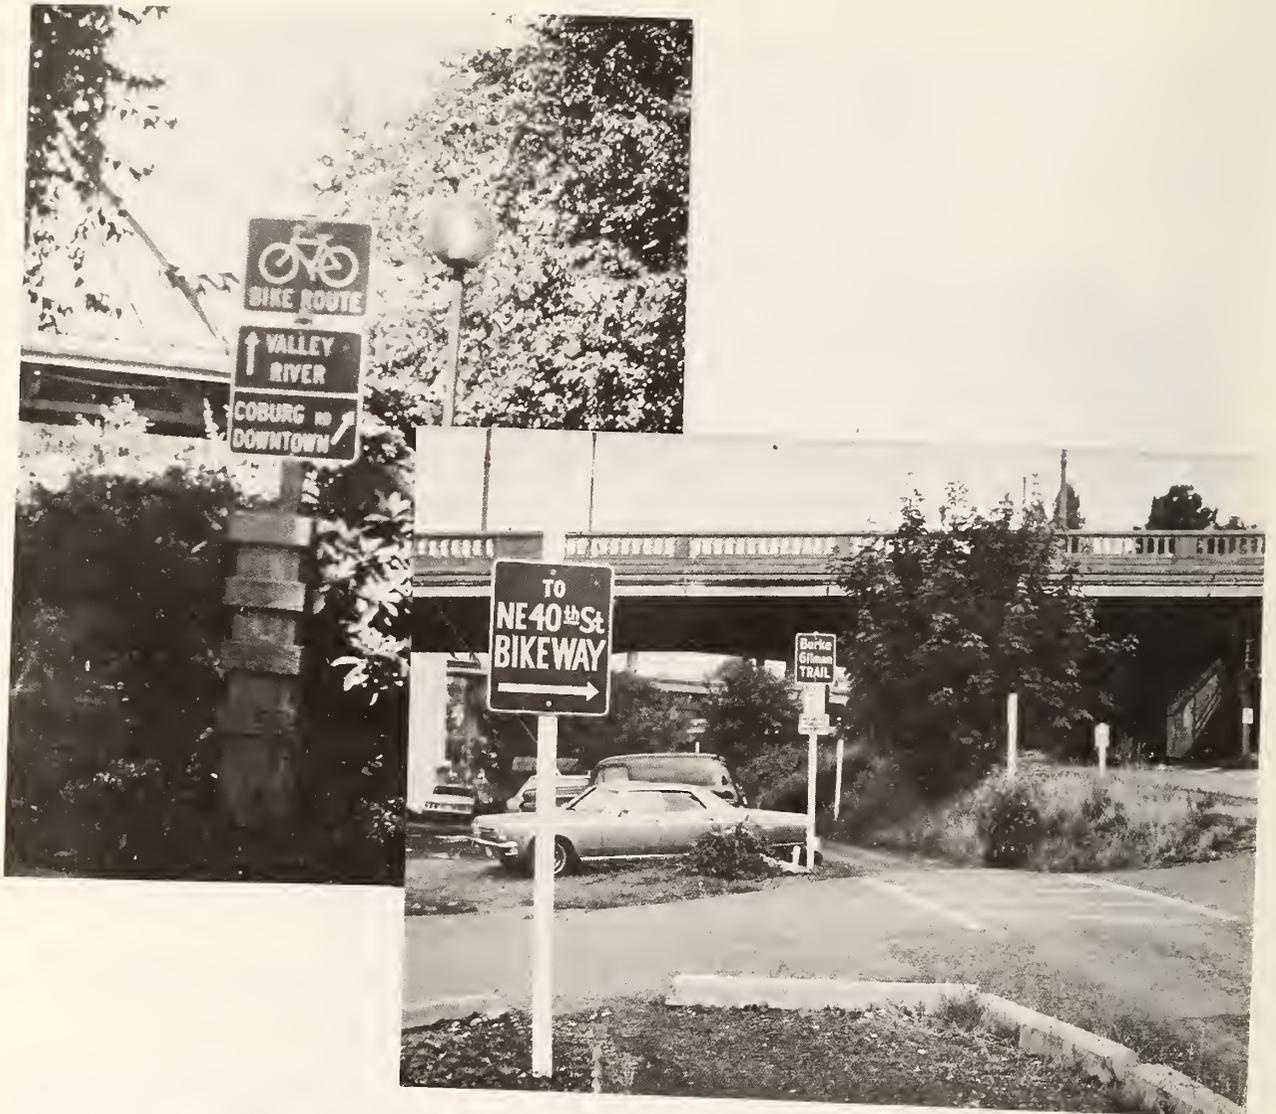
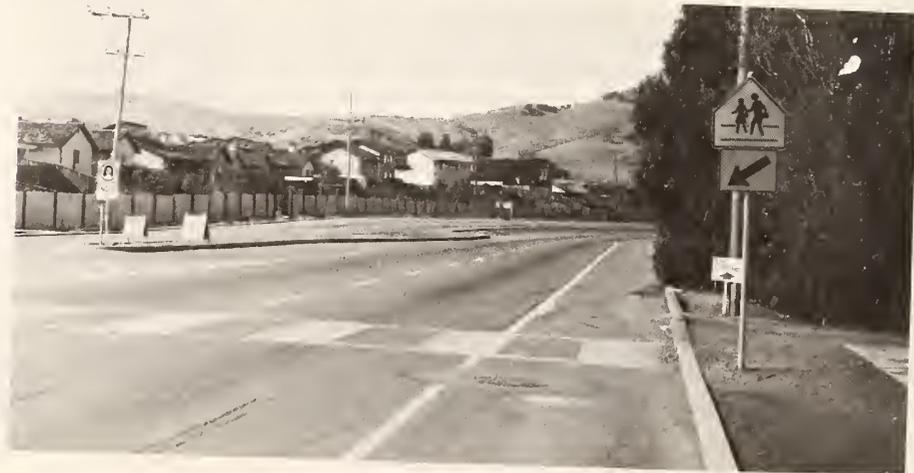
Figure 25. CROSSWALK AND GUIDE SIGNING

While these strategies may have merit in special circumstances, crosswalk delineation and warning signing should be considered first.

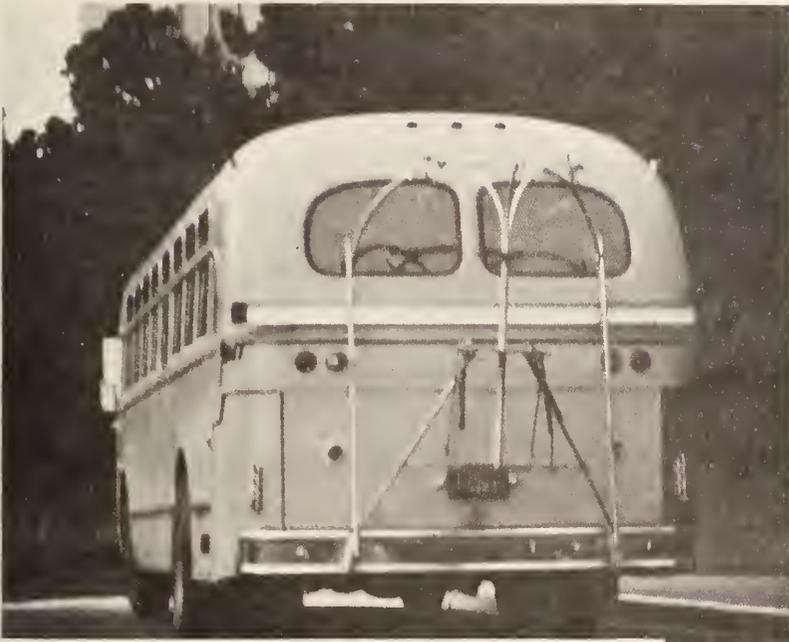
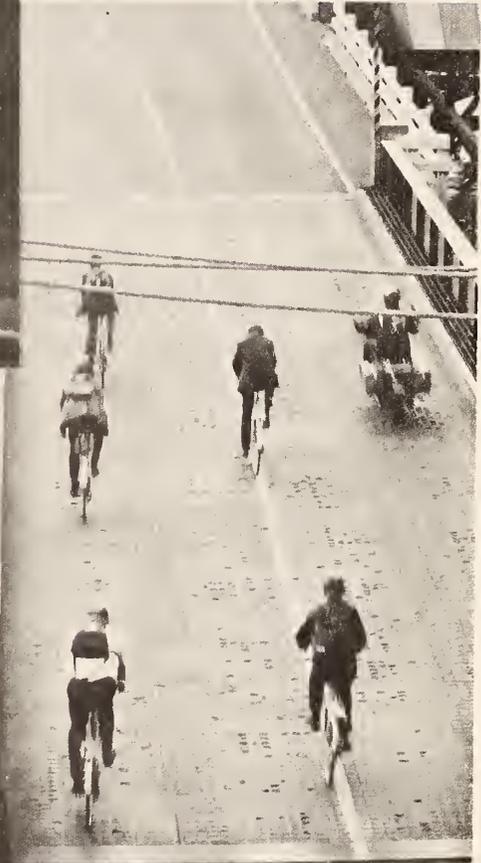
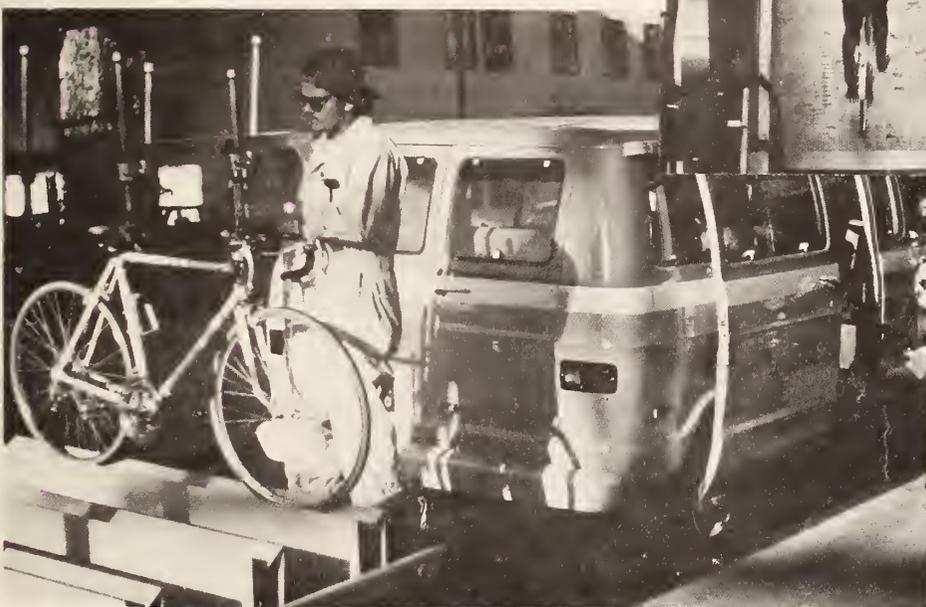
Figure 26. UTILIZING ALTERNATIVE TRAVEL MODES

Shuttle bus
with bike rack

Van with
trailer
serving as
commuter
bicycle
shuttle

- Provide Regularly Scheduled Transit. Regularly scheduled transit can provide service across structures which do not have facilities for non-motorized travel. Buses with wheelchair lifts are especially helpful to certain groups of handicapped persons. Buses can also be equiped with bicycle-carrying facilities such as racks or a trailer providing separate holding facilities. Bay Area Rapid Transit (BART) allows bicyclists to obtain a permit to carry their bicycles onto the last car of the train during off-peak times. Ferryboats also can accommodate bicyclists. (See Figure 26.)

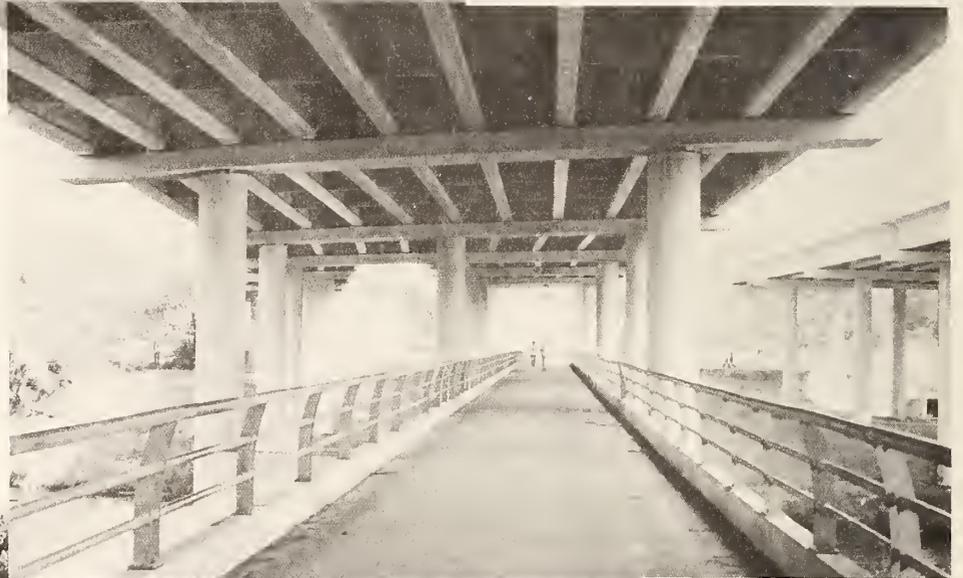
Figure 27. UNUSUAL FACILITY CONFIGURATIONS

Cantilevered walkway from underpass abutment

Pathway underneath elevated highway bridge

- It is possible to utilize the lower crossing bracing connecting overcrossing piers as support for a pathway surface. In this case, the pathway would be well below the main structure and in the open, with the bridge deck serving as a canopy. The low level pathway would be easier to gain access to where adjacent ground levels are also low. Clearance requirements beneath the structure might be a problem. (See Figure 27.)

expensive, as well as requiring users to overcome a height differential roughly double that of the cantilevered under-crossing treatment. (See Figure 27.)

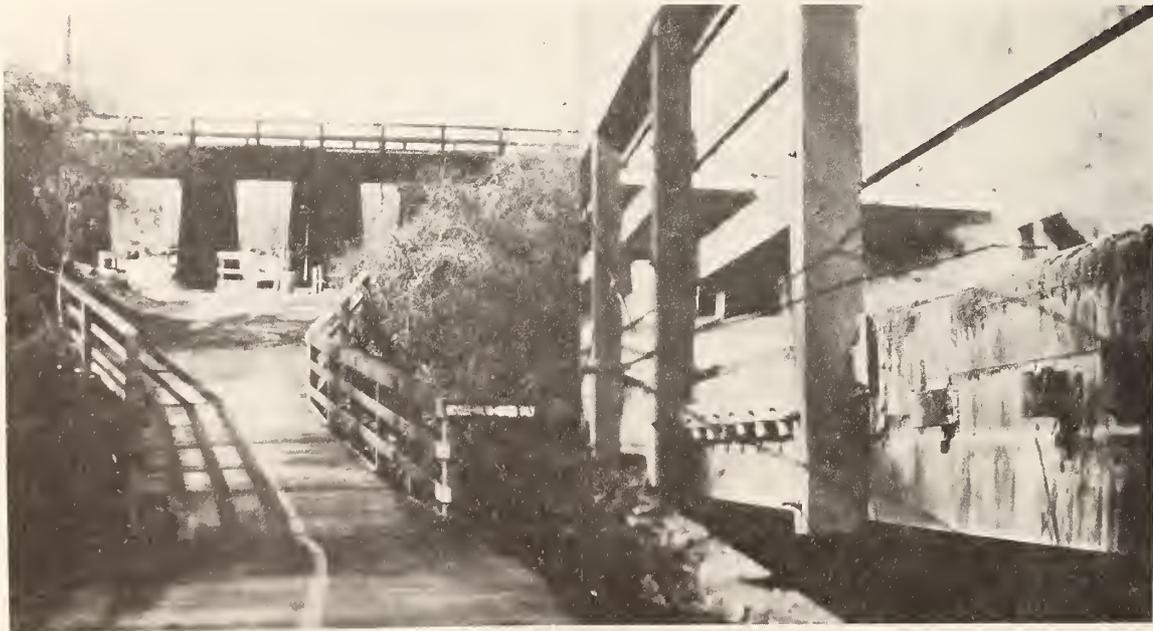
Figure 31. RAILROAD FLAT CAR BRIDGE

- Railroad flat cars are often up for sale once their useful life is over. Structural properties of a flat car make it suitable to serve as a bridge. It can be placed on abutments and new decking, handrails can be added as required. (See Figure 31.)

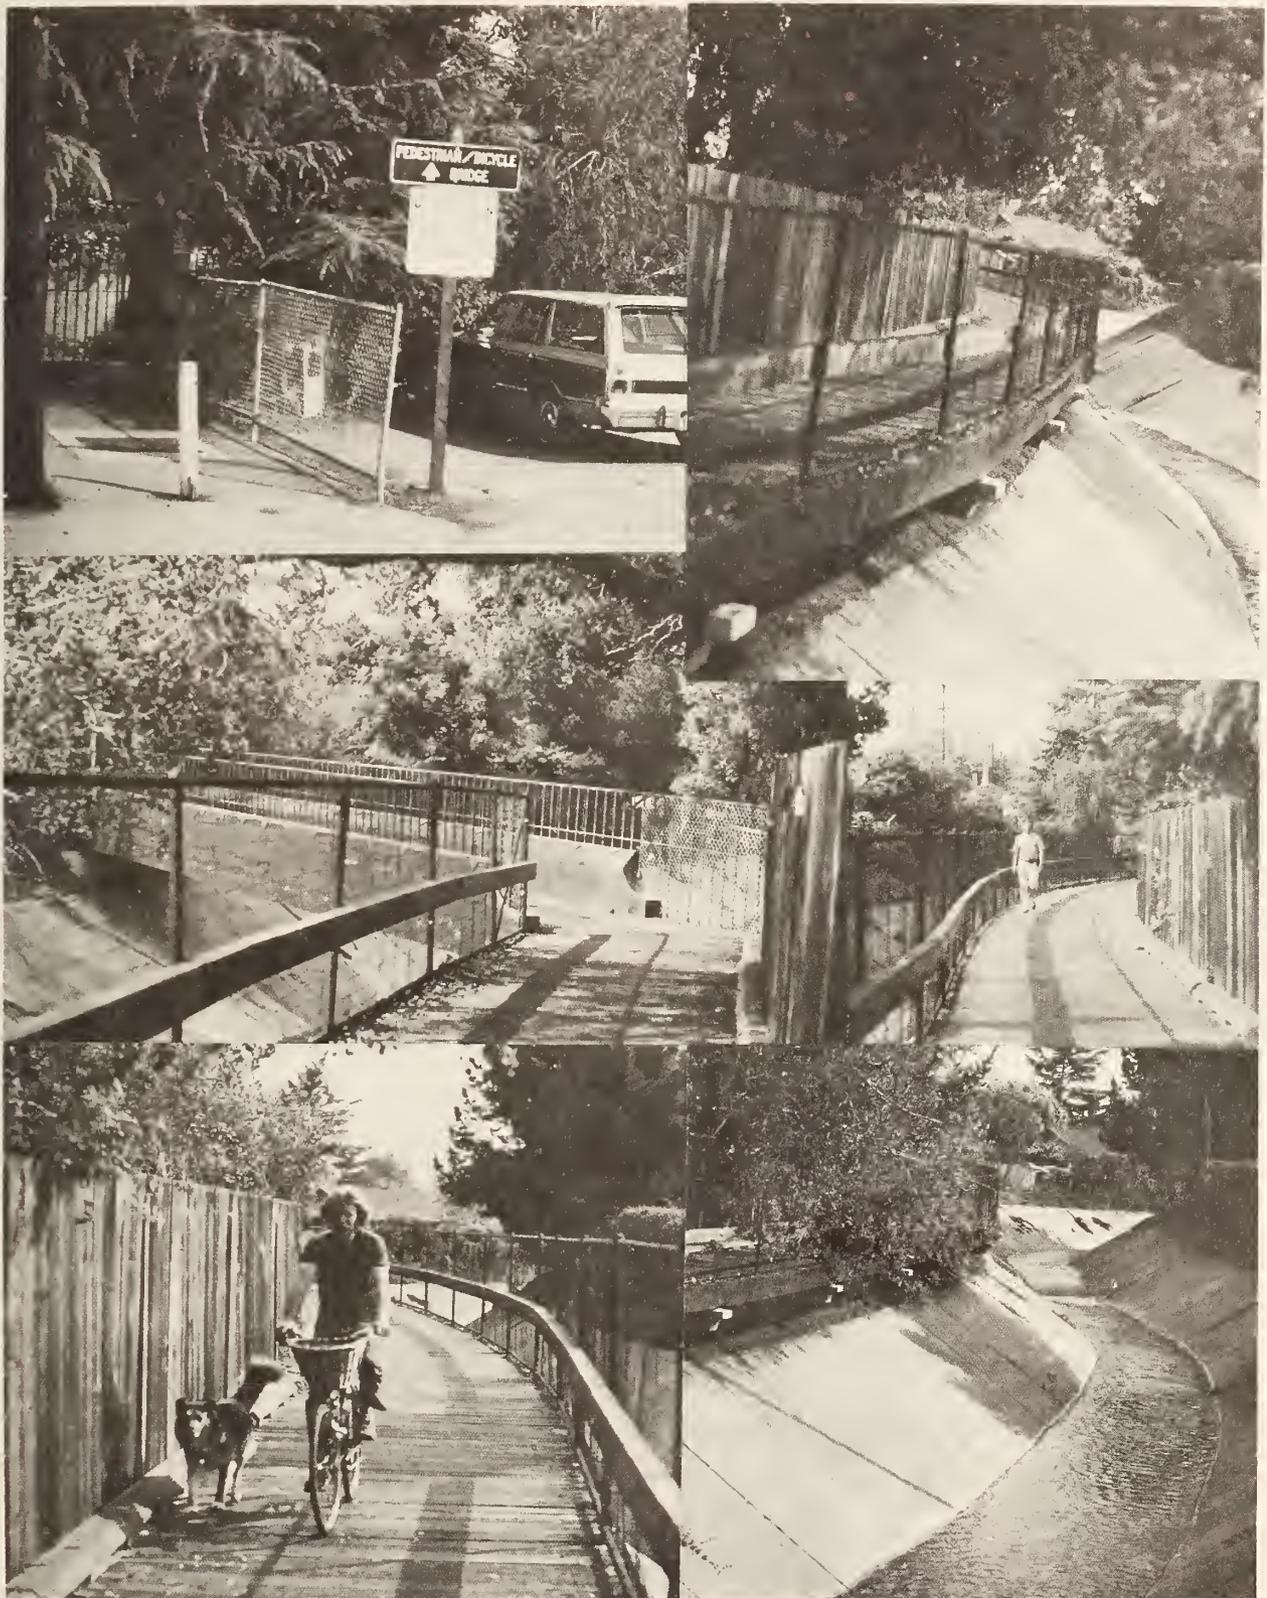
Figure 33. JAMES A. HAWKINSON PEDESTRIAN-BICYCLE BRIDGE
Palo Alto, California

The bridge spanning Adobe Creek is constructed of 11 x 45 inch (0.3 x 1.1M) 'glu lam' beams supported on reinforced concrete caissons and abutments at each end. Its length is 52 feet (15.8M). The cross bracing is one-half inch (12.2MM) diameter steel rod and the struts are four inch diameter galvanized pipe. Eight feet (2.4M) of clearance is provided between the insides of the glu lams. The decking is 4 x 8 inch (0.1 x 0.2M) lumber. Steel rods and wire mesh make up the pedestrian railings on each side that is fastened to the top of the glu lams. The total height of the railings above the decking is five feet (1.5M). See Figure 33 for a series of photographs taken at the site.

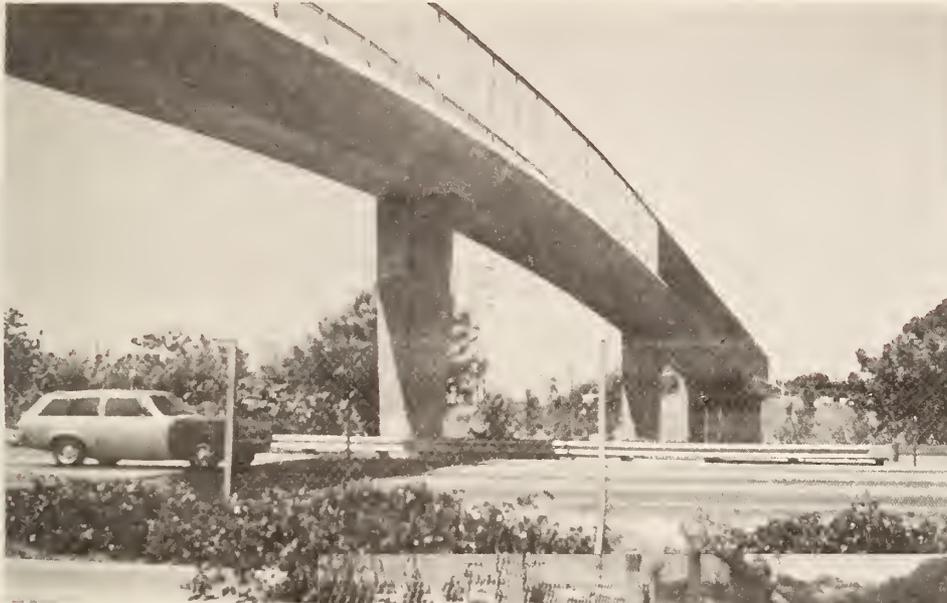
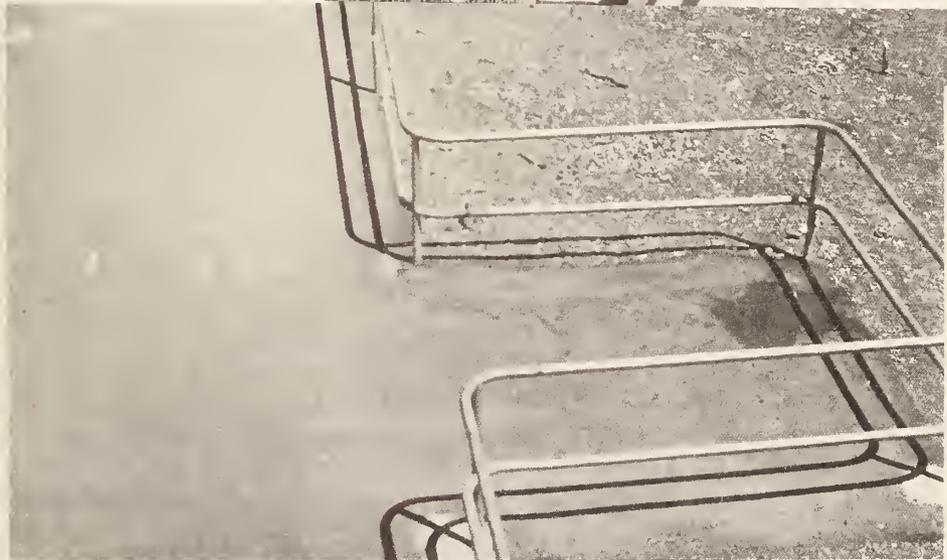
Figure 34. AHWANEE PEDESTRIAN OVERCROSSING OF ROUTE 101
Sunnyvale, California

Precast Pedestrian
overcrossing
spanning freeway

Level rest area
adjacent to
approach ramp

The pedestrian and bicycle overcrossing of Route 101 in Sunnyvale, California, was selected as one of the site evaluation studies because it represents a new, exclusively non-motorized facility with examples of the latest treatment to facilitate handicapped access. The site is shown in the photographs, Figure 34.

The Ahwanee bicycle/pedestrian overcrossing cost approximately \$316,000 to construct in 1977. The facility was completed within an eight month period. Approximate construction quantities are listed in Table 16.

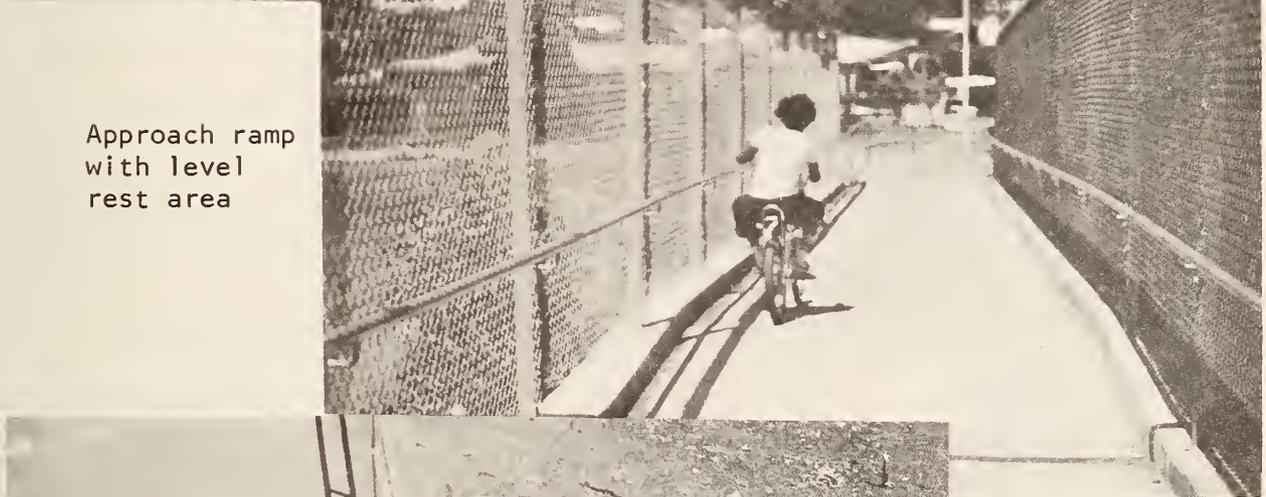
Approach ramp
with level
rest area

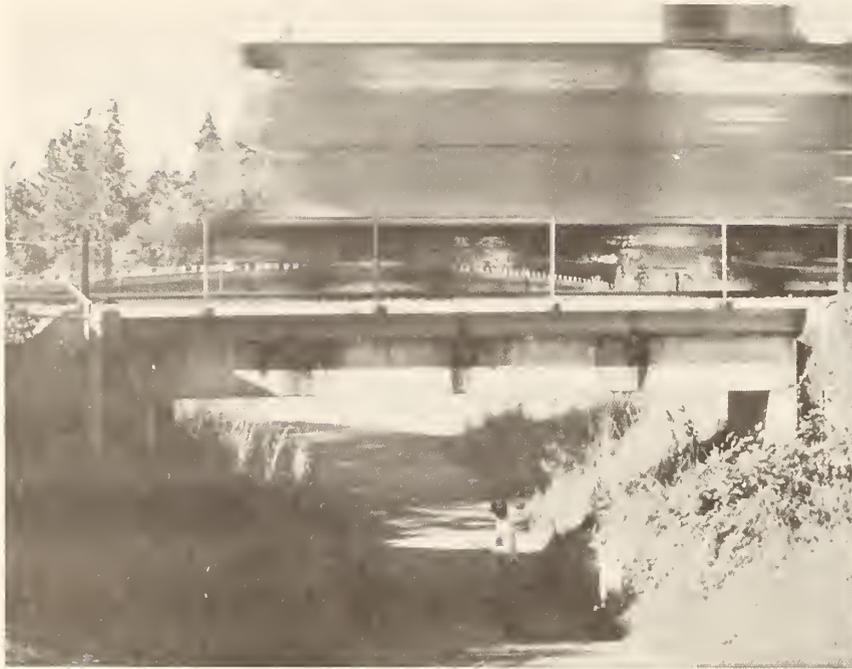
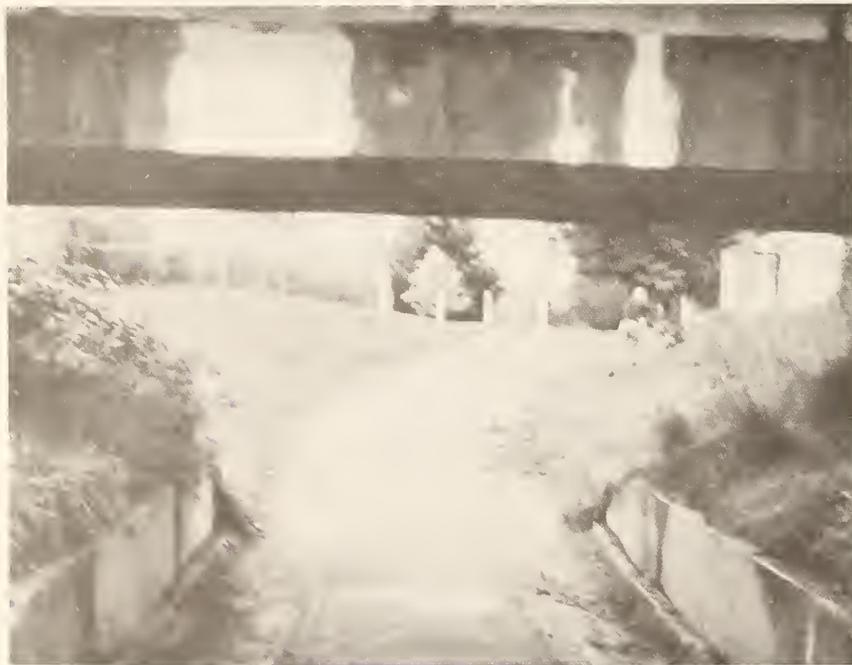
Figure 35. UNDERCROSSING OF SOUTHERN PACIFIC RAILROAD
Eugene, Oregon

The bridge consists of precast prestressed concrete box girders, and is 17 feet (5.2M) wide and 30 feet (9.1M) in length. The abutments are reinforced concrete. A 12 foot (3.7M) wide asphalt concrete path passes under the bridge on modest approach grades. The clearance above the bicycle and pedestrian path is 10 feet (3.1M). See Figure 35.

S.P.R.R. Under-
crossing providing
linkage between
the University of
Oregon and the
Autzen bridge

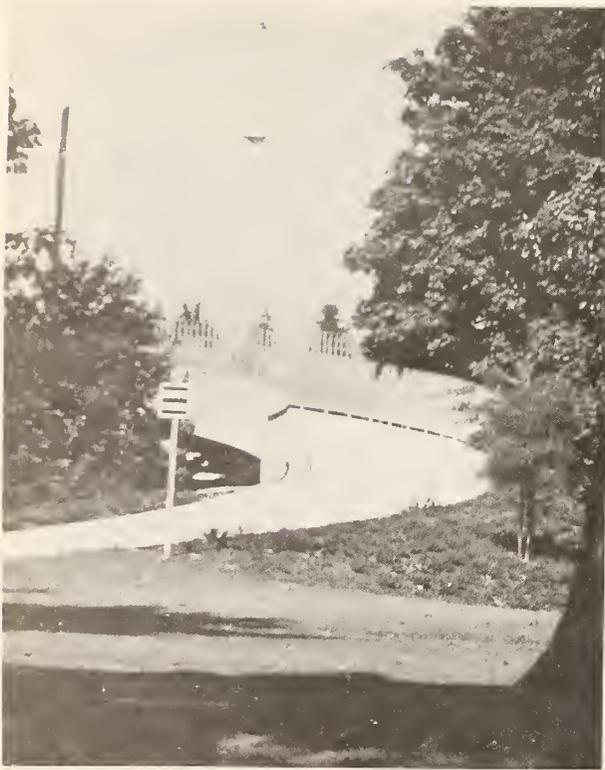
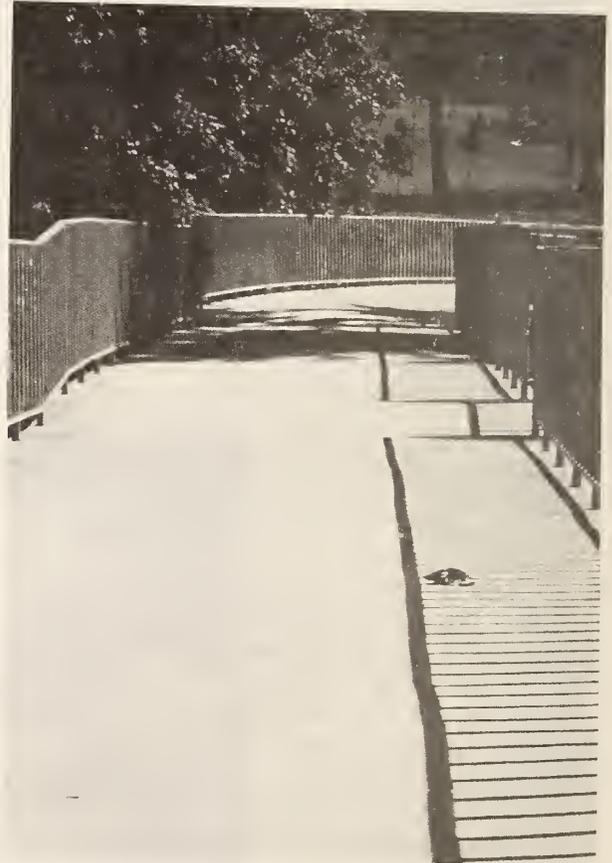
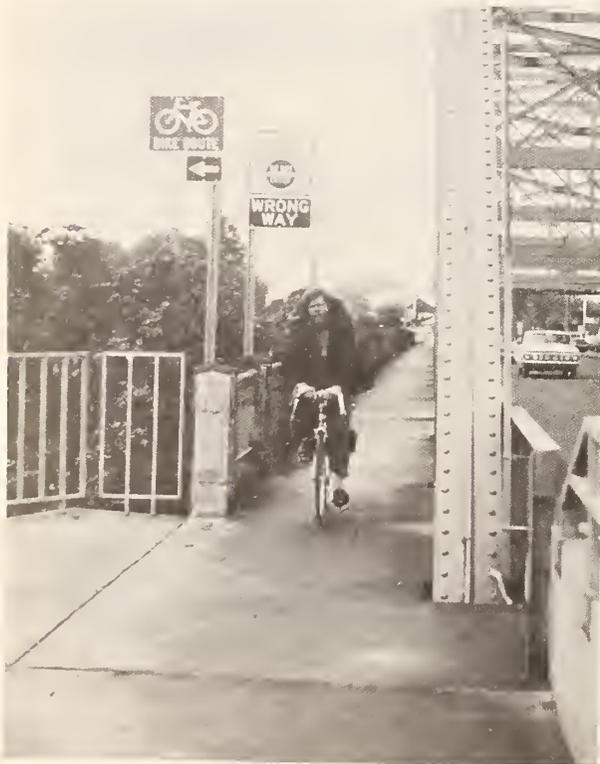
Figure 36. RETROFITTED RAMP, FERRY STEET BRIDGE
Eugene, Oregon

New ramp connecting bridge approach to ramp

View of ramp showing level rest area partially up the grade

Intersection of new ramp with original bridge approach

Proposals were made as part of the Bikeway Master Plan to remove the most serious deficiencies. The proposals were that a new access ramp be constructed on the north end of the structure, connecting the east side sidewalk approach with the North Bank Bike Path, that traffic barriers be installed adjacent to all the approach sidewalks, and that the approach sidewalk on the northeast be widened to 10 feet (3.1M) from the existing 5 feet (1.5M). The east sidewalk on the structure and approaches would be used by bicyclists only. See Figures 36 and 37.

The northeast sidewalk approach was widened by cantilevering an additional 5 foot (1.5M) section outside of the existing sidewalk. The cantilevered section is 250 feet (76.2M) in length, and provides a clear width of 10 feet (3.1M) between the new 4 foot (1.2M) high rectangular tubular steel outside pedestrian rail and the "New Jersey" type traffic barrier with handrail on the inside. The cantilevered section is supported by welded and bolted structural steel attached to the reinforced concrete beams and columns along the outside edge of the approach structure.
